Mere energetske efikasnosti (EE) i smernice za njihovo sprovodenje- program obuke za građevinske kompanije i nadzorne organe

Rezultati analize javnog građevinarstva i utvrđene mere

Zlatko Bačelić Medić
z.bacelic@ic-group.org
10/11/2016

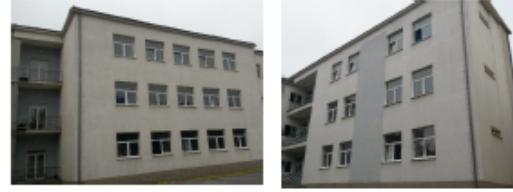
Figure 6 – Walls

Building was constructed during 1936, structurally it consists of walls made out of full brick and concrete with a thickness of 30 cm and plaster from both sides. Outside walls are assessed to be in quite a good condition from the structural point of view with some minor damages in plaster. It is recommended to install thermal insulation on the facade but minor damages have to be treated prior to EPS installation.

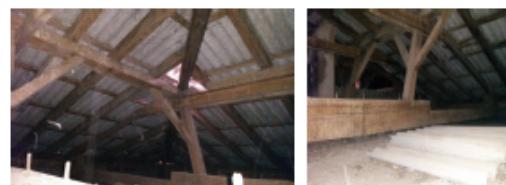
Figure 8 – Roof

According to the visual inspection, the roof has a solid wooden structure forming a regular geometric shape. Roof is assessed to be structurally sound. However, it's covered with asbestos corrugated plates which need to be removed and handled carefully by professionals. New covering should include wooden planks, vapor barrier and metallic corrugated sheets. It is recommended to install thermal insulation on the roof with a rock wool layer to be laid on the slab and covered with a protective layer of screed, but only after construction work are completed.

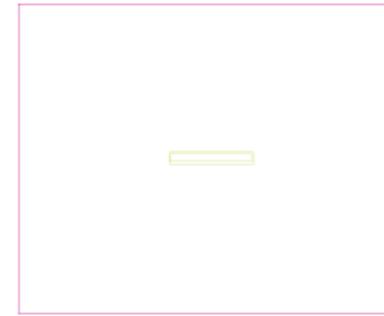
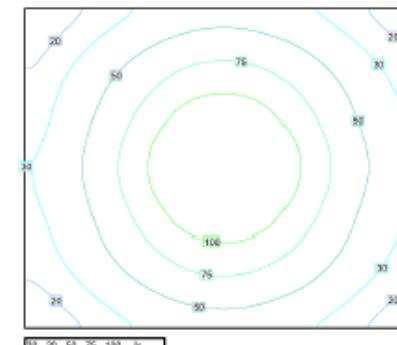
Figure 13 – Lighting simulation of one characteristic room

There are no data regarding the internal electricity distribution network. In general, the lighting is in a poor condition in terms of EE and there are no replacement parts

available. Fixtures are T8 linear fluorescent lamps operated by conventional control gear (CCG) which has placed under reflecting grill for soft light distribution and incandescent 100 W lights. Lighting measurements accounted for 190-200lux in most of the rooms and approximately the same in hallways. It is recommended to replace the lighting system with a more efficient one which will also ensure higher lighting levels which will meet the national standards. A lighting simulation of one characteristic room is provided on the figure below.

- Replacement of T8 fixtures 2x36W with HE T5 2x18W
- Replacement of T8 fixtures 1x36W with HE T5 1x18W
- Replacement of T8 fixtures 2x36W with HE T5 2x28W
- Replacement of incandescent lamps with CFL

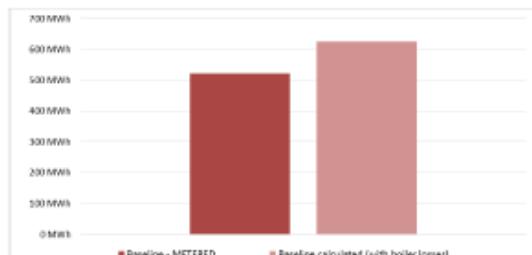
Figure 15 – Comparison of reported and calculated heating energy consumption

It was noted by the facility management and occupants that a standard level of comfort was not always achieved during the heating season.

The total calculated heating energy demand of the building amounts to 625MWh/a, while the metered energy demand amounts to 521MWh/a.
