EE measures and Implementation - Training Program for Construction Companies and Supervisors

Results of the public building analysis and typical measures identified

Zlatko Bačelić Medić
z.bacelic@ic-group.org
10/11/2016

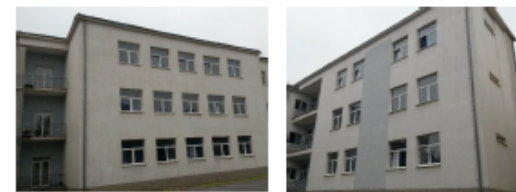
Figure 6 - Walls

Building was constructed during 1936, structurally it consists of walls made out of full brick and concrete with a thickness of 33 cm and plaster from both sides. Outside walls are assessed to be in quite a good condition from the structural point of view with some minor damages in plaster. It is recommended to install thermal insulation on the facade but minor damages have to be treated prior to EPS installation.

The existing layers are presented in Table 3. Existing wall can be seen in photos, Figure 6.

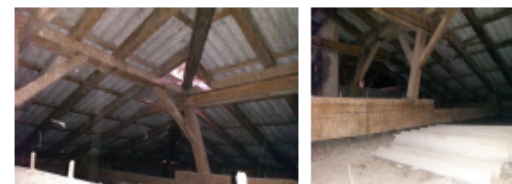
Figure 8 – Roof

According to the visual inspection, the roof has a solid wooden structure forming a regular geometric shape. Roof is assessed to be structurally sound. However, it is covered with asbestos corrugated plates which need to be removed and handled carefully by professionals. New covering should include wooden planks, vapor barrier and metallic corrugated sheets. It is recommended to install thermal insulation on the roof with a rock wool layer to be laid on the slab and covered with a protective layer of screed, but only after construction works are completed.

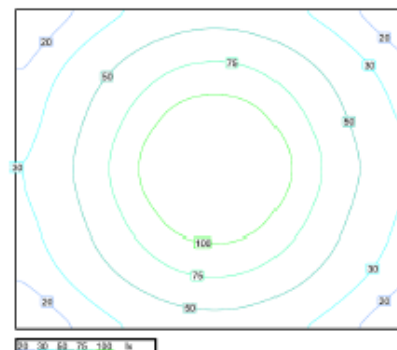
Figure 13 – Lighting simulation of one characteristic room

available. Fixtures are T8 linear fluorescent lamps operated by conventional control gear (COG) which has placed under reflecting grill for soft light distribution and incandescent 100 W lights. Lighting measurements accounted for 150-200lux in most of the rooms and approximately the same in hallways. It is recommended to replace the lighting system with a more efficient one which will also ensure higher lighting level which will meet the national standards. A lighting simulation of one characteristic room is provided on the figure below.
